## Conservative historic building conservation Cadwraeth “geidwadol” ar adeiladau hanesyddol

THIS PAPER CONSIDERS “conservative” historic building conservation in Wales. The illustrations are principally of farmhouses in Mid Wales originating during the mid fifteenth-century post-Glyndŵr rebuilding.

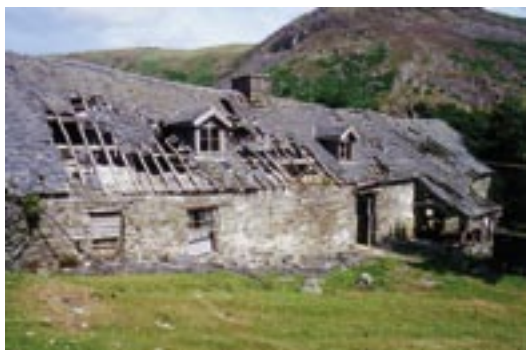
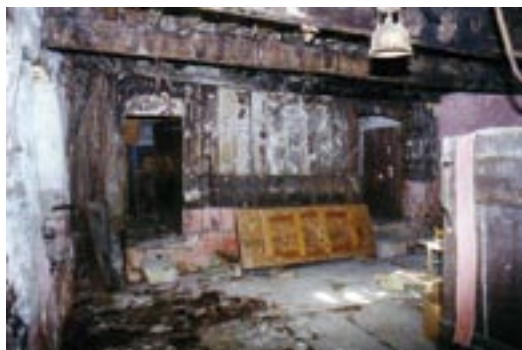
◀ **Llanerch-y-cawr**  
before restoration/cyn yr adfer  
(Mike Garner)

The first building to illustrate much of what I want to say is Llanerch-y-cawr in the Elan Valley. It had been derelict for years before the Elan Valley Trust decided to take it out of farm tenancy, restore it and let it for holiday use. It was at this stage unroofed and saturated; the interior looked incapable of being salvaged. Tarpaulins had been used to protect the house, but had taken off most the slates when disturbed by wind; they had caused more harm than good. I do not, therefore, advise the use of tarpaulins, and I would advise any surveyor not to survey a building in this sort of soggy condition. The client was persuaded to erect a temporary structure over the house, and following drying out rubbish was removed and a proper survey carried out. Far more was found to be sound than originally anticipated.

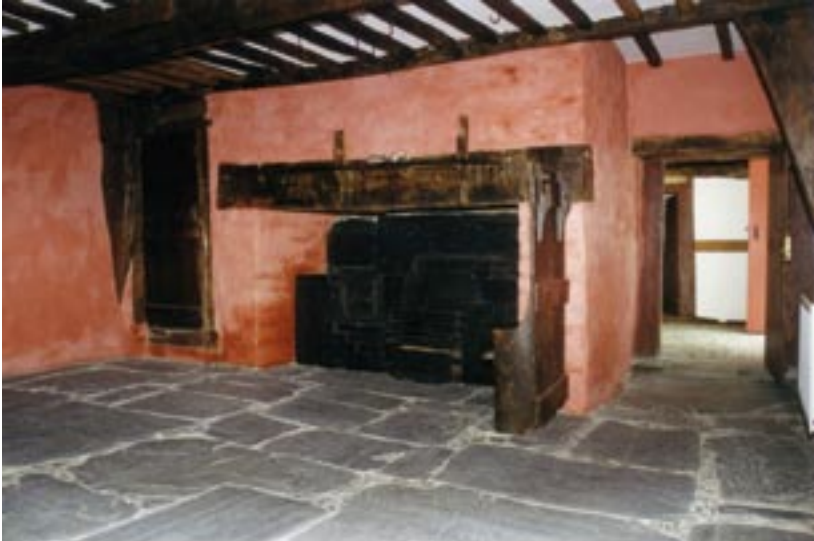
▲  
**Llanerch-y-cawr** The 17th-century floor beams were strengthened and retained  
 Cryfhawyd y trawstiau 17 ganrif a'u cadw (Mike Garner)

One recurring problem with such buildings is the need to relieve purlins or beams that are over stressed owing to decay, original under-design, or the need to increase loadings. We frequently size new rafters to enable them to span twice the distance, thus missing out particularly poor timbers. We can half-lap new rafters at the ridge level to decrease loads on the upper parts of trusses and upper purlins and insert stainless steel fitch plates in pur-

lins to increase load-bearing capacity. We also strengthen floor beams this way. This enables us to maintain the maximum amount of historic material.

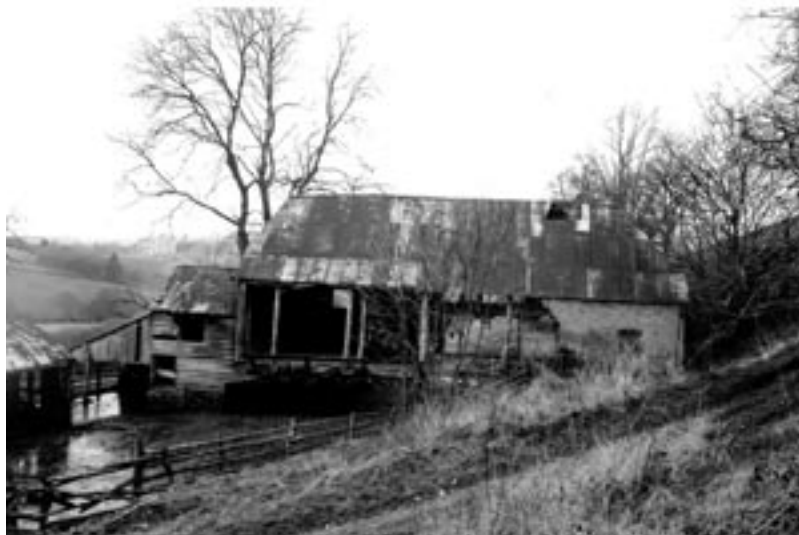
**Tŷ Mawr** before restoration  
ar ôl y gwaith adferol  
(Mike Garner)

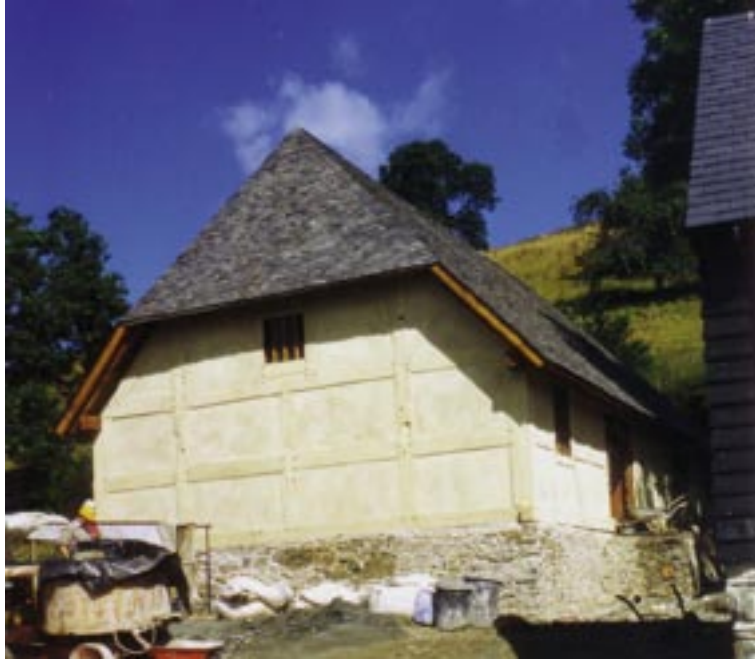
◀  
**Tŷ Mawr**  
 after conservation  
 ar ôl y gwaith adferol

frame and infill panels, all the problems of shrinkage, shakes and draughts came into play. I decided to follow historical evidence and limewash the whole exterior, timber frame and panels to seal the gaps. This has since been carried out during maintenance and has proved a successful strategy.
