## Conservative historic building conservation Cadwraeth “geidwadol” ar adeiladau hanesyddol

THIS PAPER CONSIDERS “conservative” historic building conservation in Wales. The illustrations are principally of farmhouses in Mid Wales originating during the mid fifteenth-century post-Glyndŵr rebuilding.

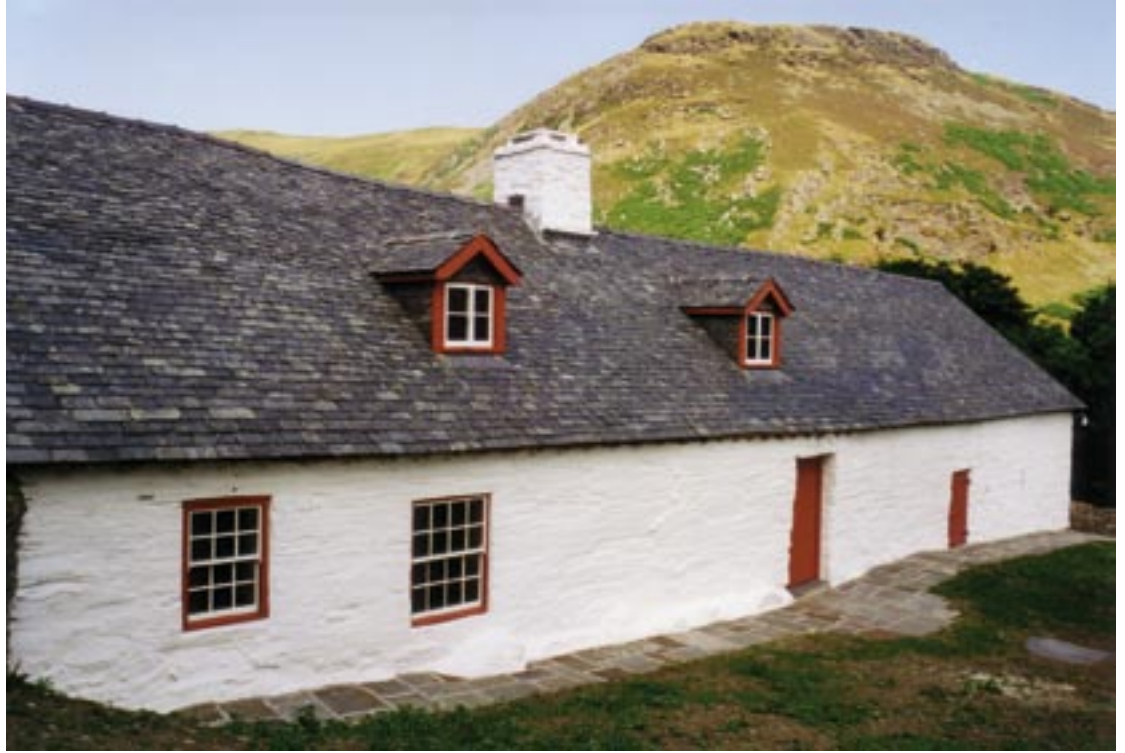
▶  
**Llanerch-y-cawr**

At Llanerch-y-cawr there was a specific problem with the central chimney inserted into the open hall in the sixteenth century. The fifteenth-century cruck truss originally abutted the stack but when the seventeenth-century first floor was inserted an additional stone fireplace was tacked on the face of the main stack. With the decay in the feet of the cruck and in the later beam the whole assembly was cracking the stack. Our strategy was to carefully number the stones and dismantle the attached fireplace, strengthen the seventeenth-century beam to take the load of the fireplace, carry out repairs to the cruck feet so that load was no longer taken on the later stonework, and reconstruct the fireplace. As re-roofing was required, we were able to achieve good roof insulation using a warm roof structure, but the remainder of the building was repaired as originally built. Walls were bag-pointed and limewashed in their original colours. No damp-proof course was inserted into the walls; stone slab floors were not taken up but simply repaired; and ground levels were cleared of generations of debris to their original levels. The original stone drain parallel to the back gable wall was located, cleaned out and extended. No damp proof membrane was included underneath the floors. Windows were repaired to their original detail. The end result is a remarkably dry, friendly and comfortable house.

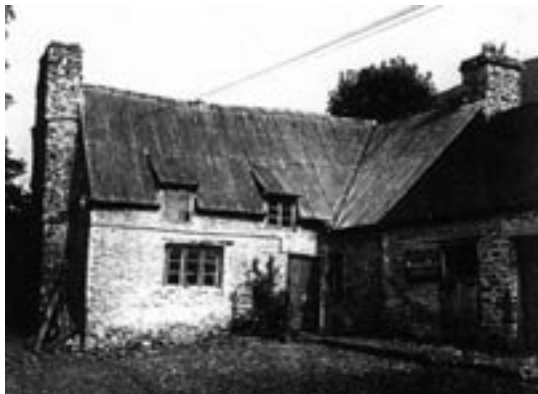
### Radnorshire

My last example is perhaps the most extreme – a house that had begun to be “improved” with all the necessary statutory approvals in place but which became abandoned through lack of funds.

Regrettably, it has been the case in Radnorshire that people attracted to derelict buildings and their low capital costs sometimes lack the resources to match-fund a proper restoration. The Royal Commission on Ancient and Historical Monuments in Wales had recorded this south Radnorshire structure in the 1960s. There was a gap of about ten years between the building being unroofed and repairs to the masonry being started in blockwork and brickwork and it being sold to my client. The client is happy for me to use the illustrations but does not want me to identify the house. My brief from him was quite specific: to use the Royal Commission’s records to repair the house to its original appearance and not to use any modern materials – no damp-proof courses, no damp-proof membrane, no underfelt in the roof. He had no intention of installing a general electrical installation or central heating and did not require insulation because he didn’t feel the cold. Many of the missing internal features, such as bits of the staircase, were discovered re-used in the garden or buried under the straw in the barn.
